**PROJECT:** Midnite Mine Remediation

**REPORT NO:** 2019-015

### MIDNITE MINE HEALTH & SAFETY SUMMARY: Reporting Period July 5 – July 11, 2019

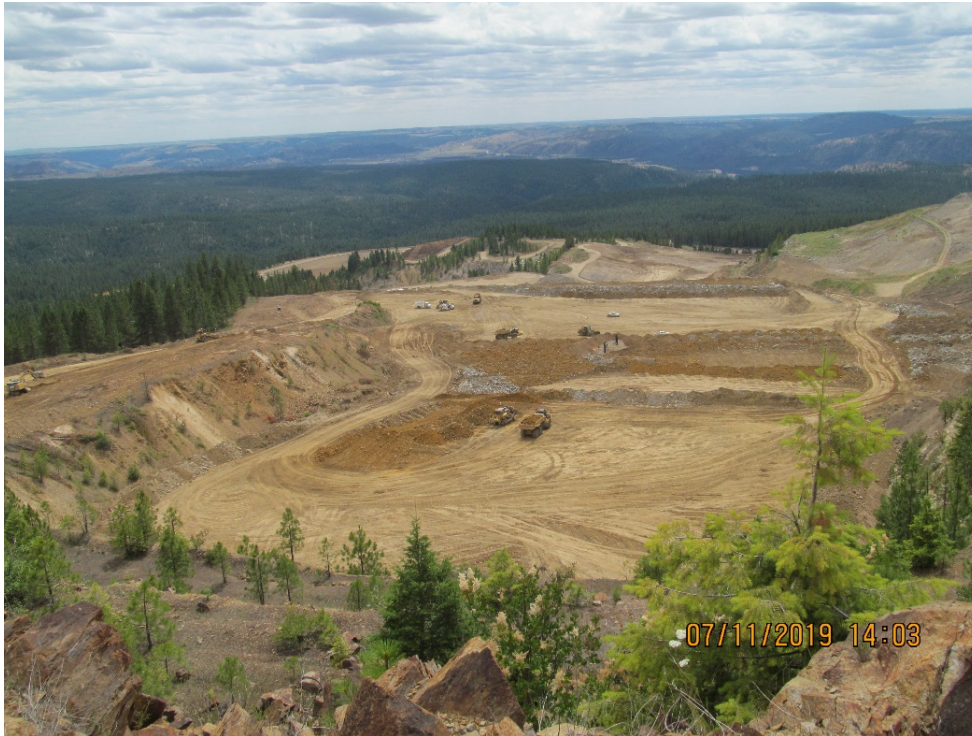
**Figure 1 – Overview of Pit 4, Looking South**

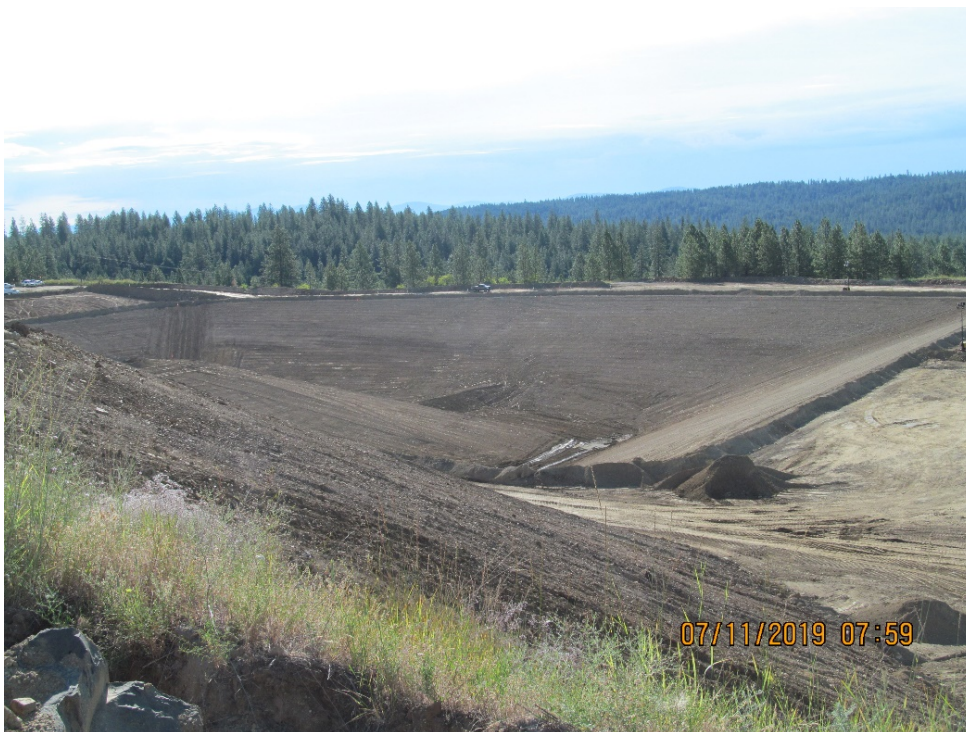
**Figure 2 – South Pond Excavation – Looking Southeast**

- A Cat D6 dozer was used to shape the South Pond on the SWRP to final grade. Minor amounts of additional excavated low activity/low reactivity material from South Pond final grading was hauled and placed in Pit 4. By the end of this week, the South Pond excavation was largely complete with the exception of the pipe trenches and leak detection sumps in the pond bottom.

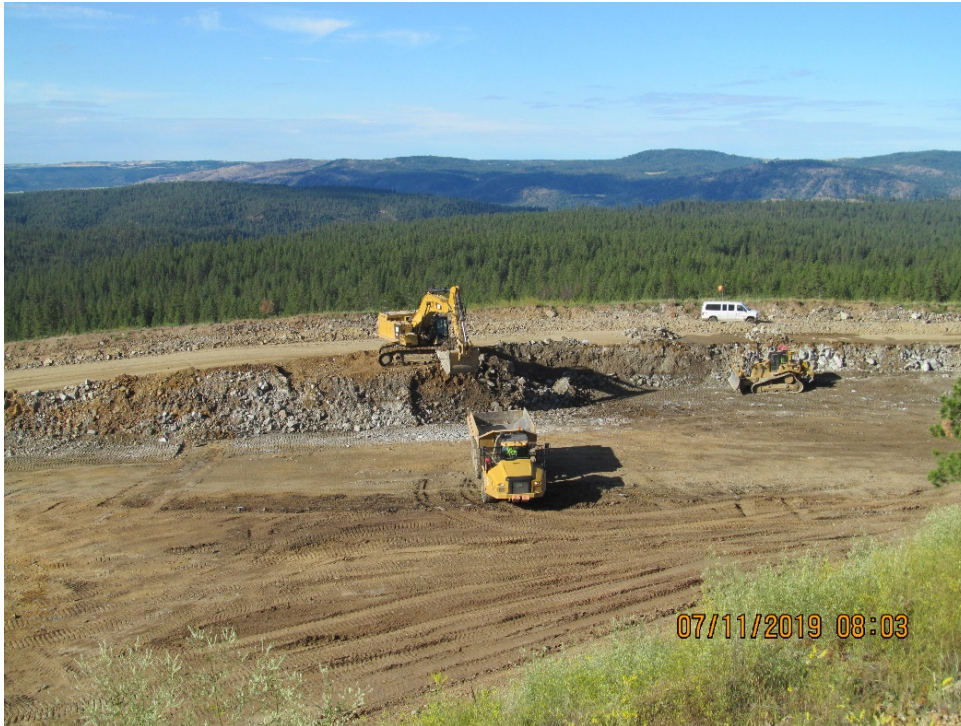
**Figure 3 – Load-Out at the S-SWRP, Looking West**

- No remedial construction activities were performed on July 5, 2019.
- Continued excavating, hauling and placing low activity/low reactivity material from South Waste Rock Pile (SWRP) west of the South Pond in Pit 4. Material from SWRP was placed on the north, east, and west sides of Pit 4 to create the 20' rind buffer area, at the south end of the Pit 4 backfill to form the 20' radon buffer on the outer waste surface, and in the unclassified waste zone in the interior of the pit.

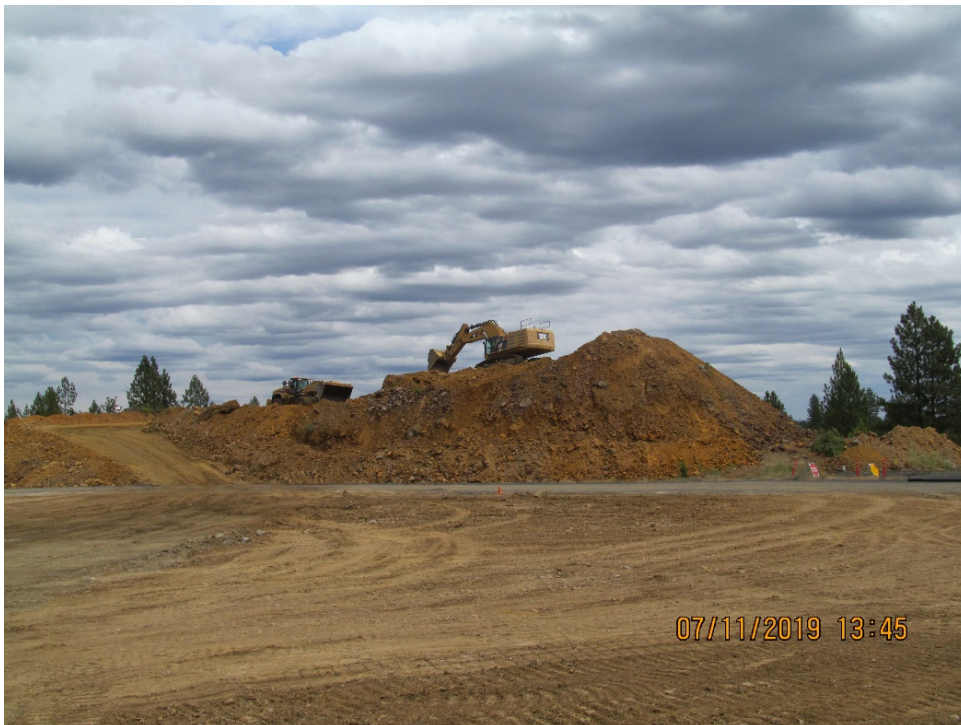
**Figure 4 – Load-out at Stockpile 2, Looking Southeast**

- Began excavating, hauling and placing high activity/high reactivity material from Ore Stockpile 2 (Stockpile 2) in Pit 4. High activity/high reactivity material was placed in the unclassified waste zone in the interior of the Pit 4 backfill.
